Restored Juno Terrace in the Palazzo Vecchio and Verrocchio's *Putto* on View Together Again

Restoration completed thanks to the generosity of the Friends of Florence

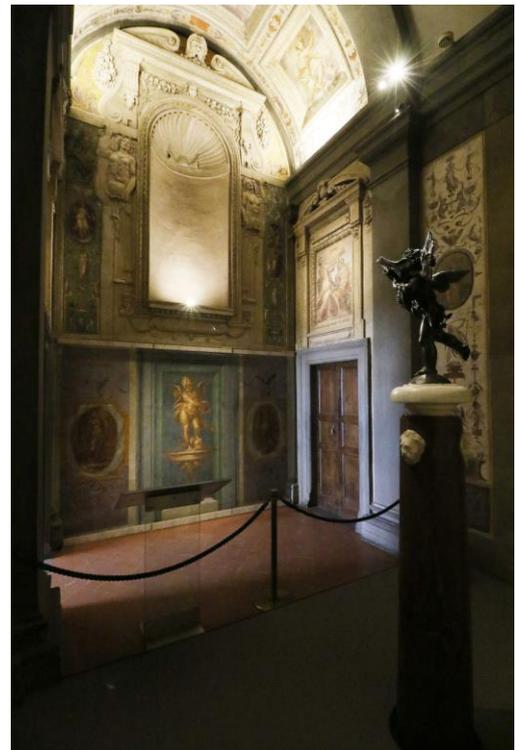
Juno Terrace and Andrea del Verrocchio's *Putto with a Dolphin*, Palazzo Vecchio Museum, Florence, Italy. Restored with support from the Friends of Florence. Photograph: Ottaviano Caruso

When the work was completed, Verrocchio's *Putto with a Dolphin* was reinstalled in the room. Finally, tempered anti-reflective glass panels were mounted to protect the frescoes and the lighting system upgraded to markedly improve the viewing experience.

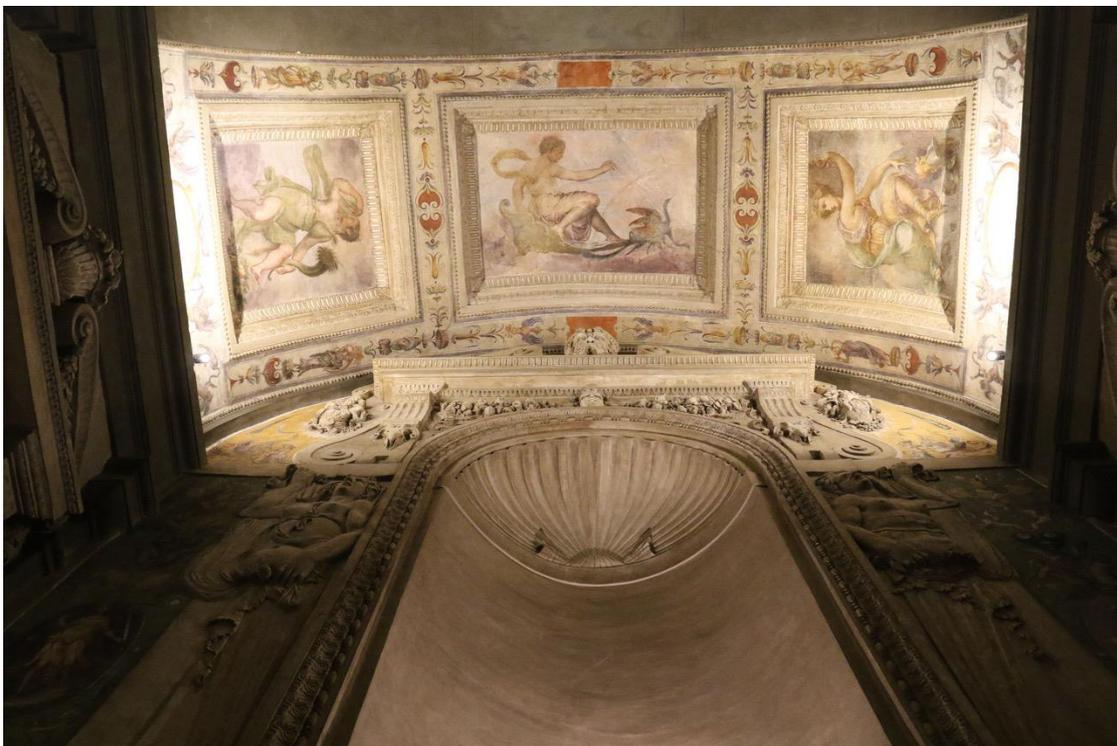
Interior frescos, Juno Terrace, Palazzo Vecchio Museum, Florence, Italy. Restored with support from the Friends of Florence Foundation. Photograph: Ottaviano Caruso

The restoration project was complex and multi-faceted. The interior frescoes, for example, showed extensive overpainting, numerous attempts at reconstruction, and different types of glues and resins from previous restorations. There was blistering and loss of the paint layer, detachment of the preparatory layers, and the use of fillers was evident. To maintain the legibility of the fresco, it was necessary to preserve some reconstructions without compromising the quality and colors of the original frescoes. The surfaces required careful cleaning using a delicate procedure enabling retrieval of the original painting and, while diminishing their visual impact, saved the reconstructions of essential portions such as Juno's head, parts of her body, and the peacocks.

The stucco decorations were covered with a thick layer of dust and a yellowish patina that also extended to the white bases of decorative elements. Some of the molded cornices had deteriorated. The careful removal of the surface patina and cleaning brought to light several reconstructions. Both the old and new fillers were camouflaged with watercolors.
